The Corporation of the Village of Cumberland  
Committee of the Whole Meeting Agenda

4.1 Perseverance Creek Flood Risk Assessment  
Prepared by Kevin McPhedran, Director of Community Services

# Perseverance Creek Flood Risk Assessment

## Options Analysis and Class 1 Risk Assessment

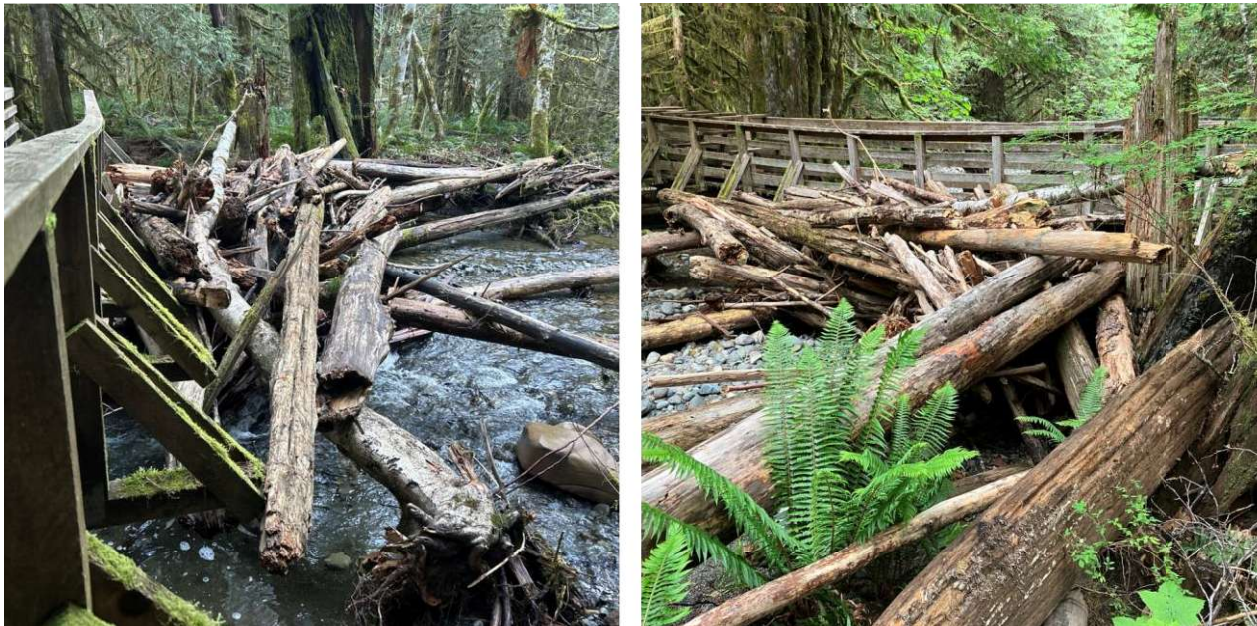
**Figure 1.1** Looking at log jam on upstream side of Hai Gai trail bridge. Left photo taken from river left on April 7, 2026. Right photo taken from river right on June 10, 2026.

In the short-term, NHC recommends removing the trail bridge and log jam to reduce the chance of an outburst-type event potentially causing damage to the well and associated linear infrastructure, as well as posing a Risk to public safety in the area. This may carry an increased Risk of surface water flooding this winter during low and medium flows, but the amount of damage from an outburst type event is more uncertain and potentially more severe. We have therefore assigned it a greater Risk.

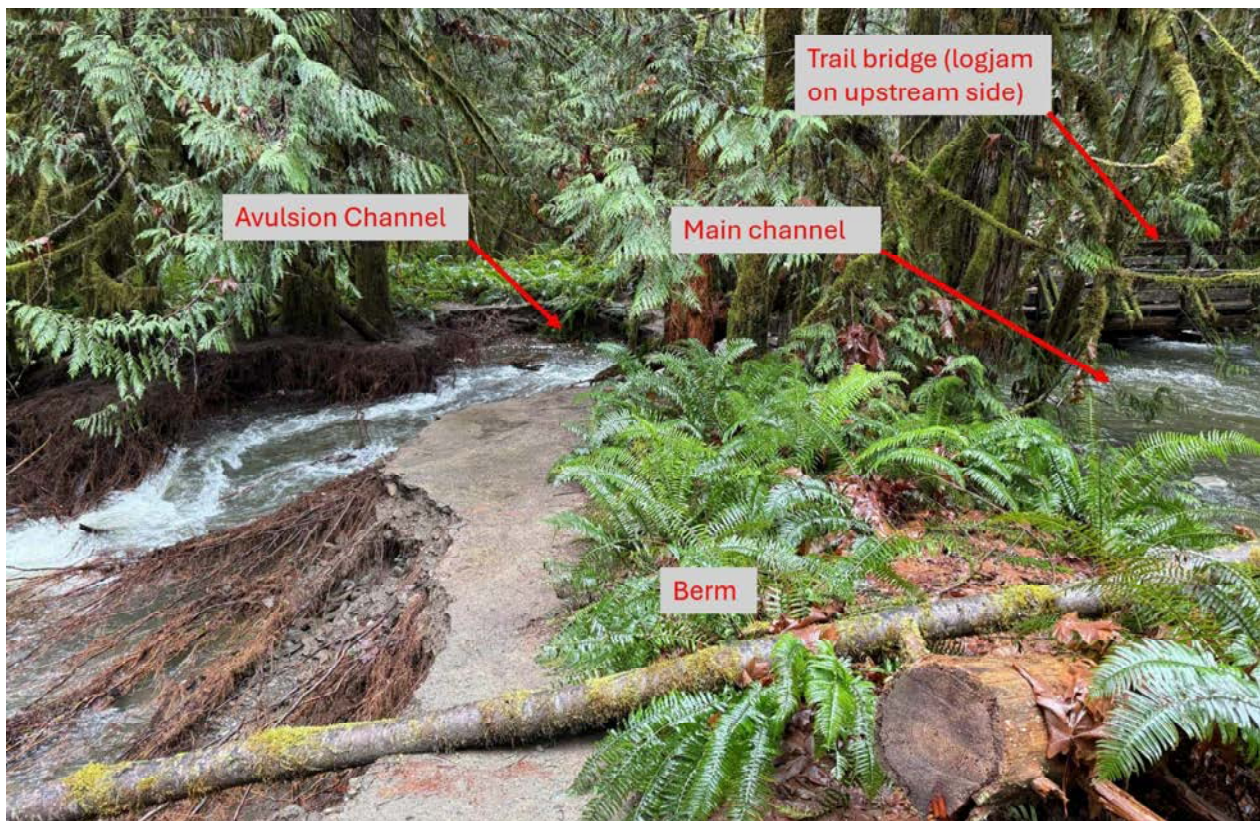
**Figure 1.2** Looking upstream at avulsion channel and Perseverance Creek main channel on February 1, 2026. Photo courtesy of Adam Silverstein.

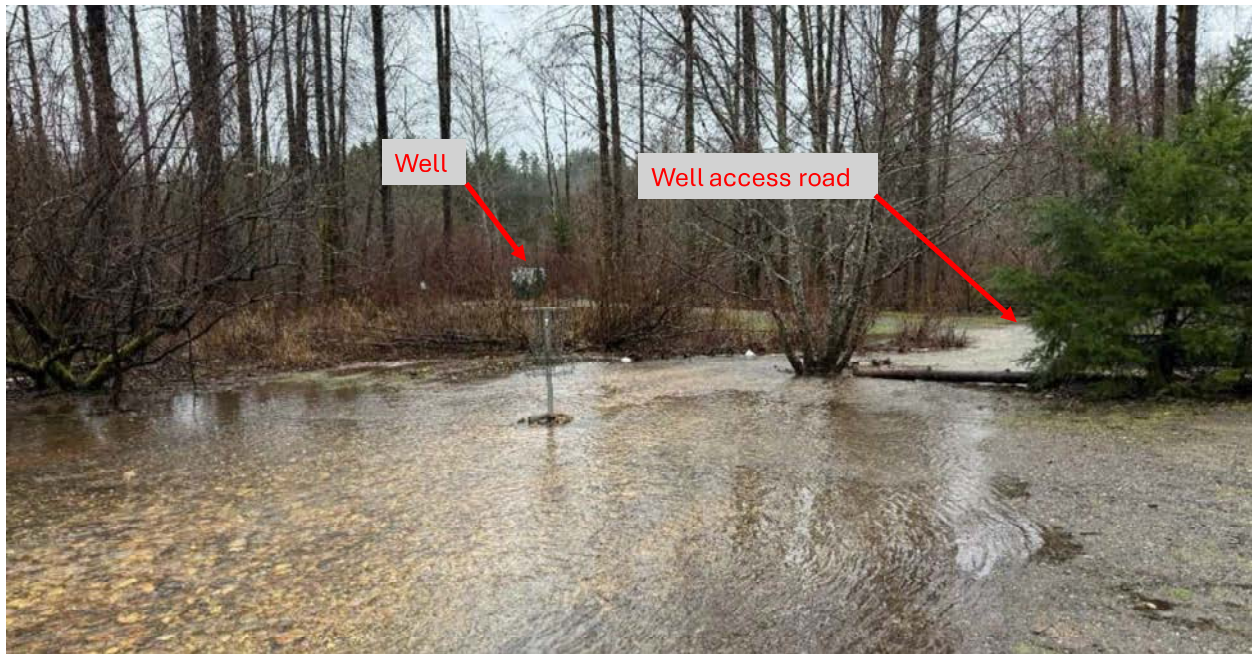
**Figure 1.3** Looking downstream along avulsion channel in disc golf course on February 1, 2026, showing groundwater drinking water supply well and flooded access road for it. Photo courtesy of Adam Silverstein.

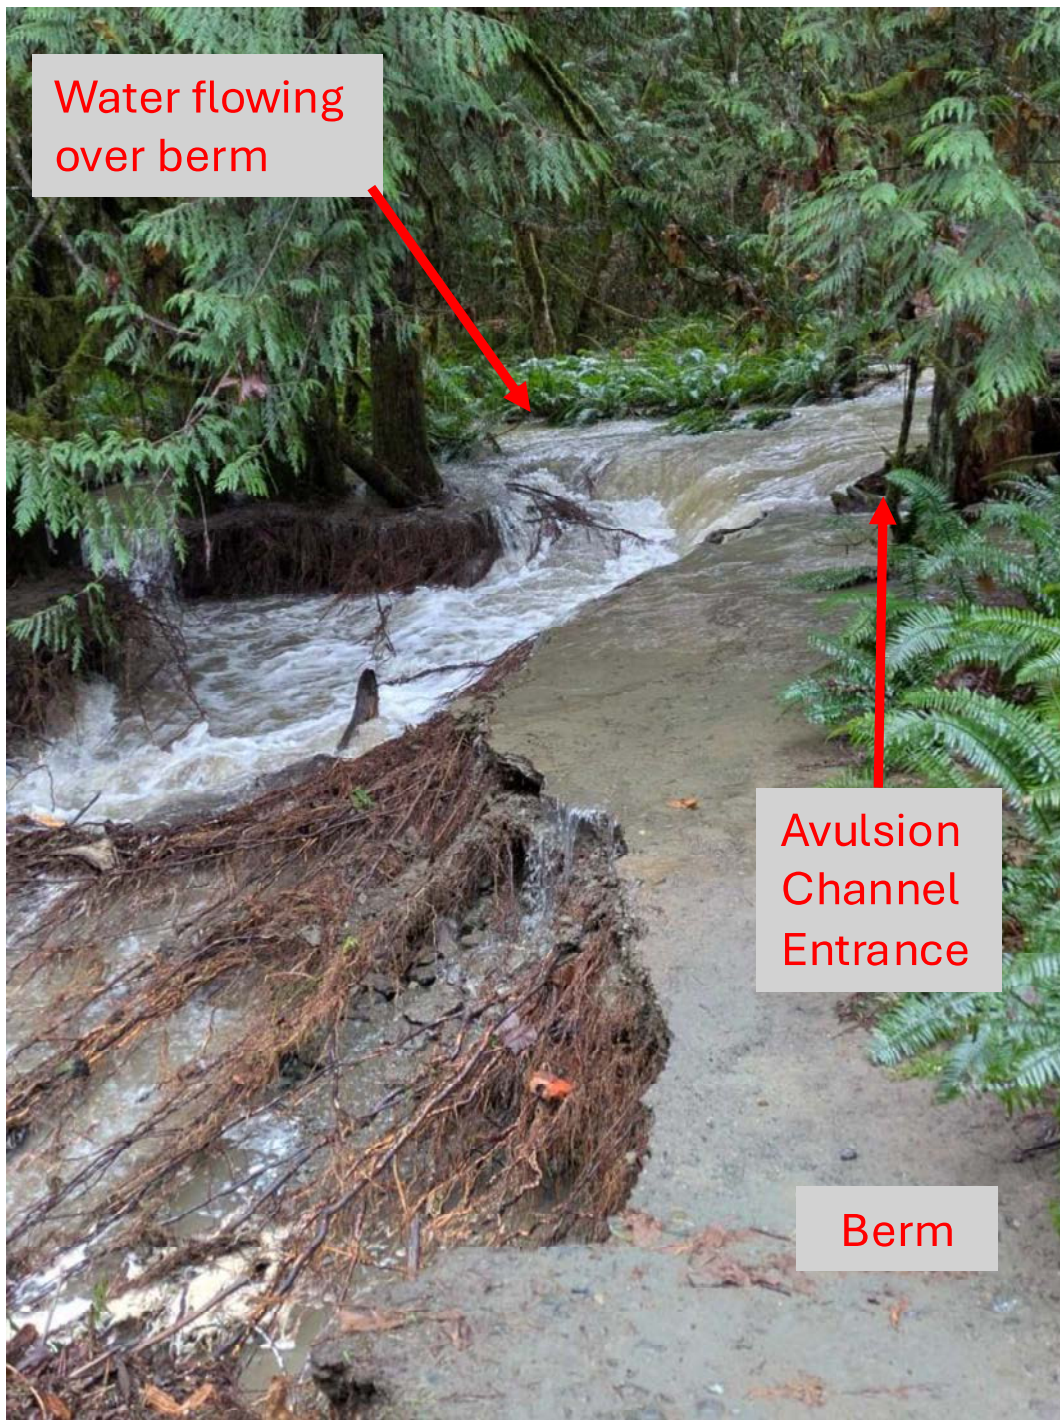
Photos from January 30 show water flowing over the berm into the avulsion channel (Figure 3.4). There is also a small entrance to the avulsion channel under the river right bridge abutment that diverts a portion of the flow from Perseverance Creek (Figure 3.5, Figure 3.6, Figure 3.7). This entrance is at a lower elevation than the main channel bed, has a smaller cross-sectional area than the main channel, and has a log jam between it and the main channel. While the lower entrance means water will flow into the avulsion channel before the mainstem, its small cross-sectional area suggests that as flows increase, an increasing proportion of the water will flow down the main Perseverance Creek channel, until flows become high enough where water can flow over the berm again. This presents trade-offs when considering whether to remove the jam, which are discussed in 4.2.1.

**Figure 3.4** Looking upstream at avulsion channel entrance on January 30, 2026. Photo by Heather Mathers (Perseverance Creek Streamkeeper).

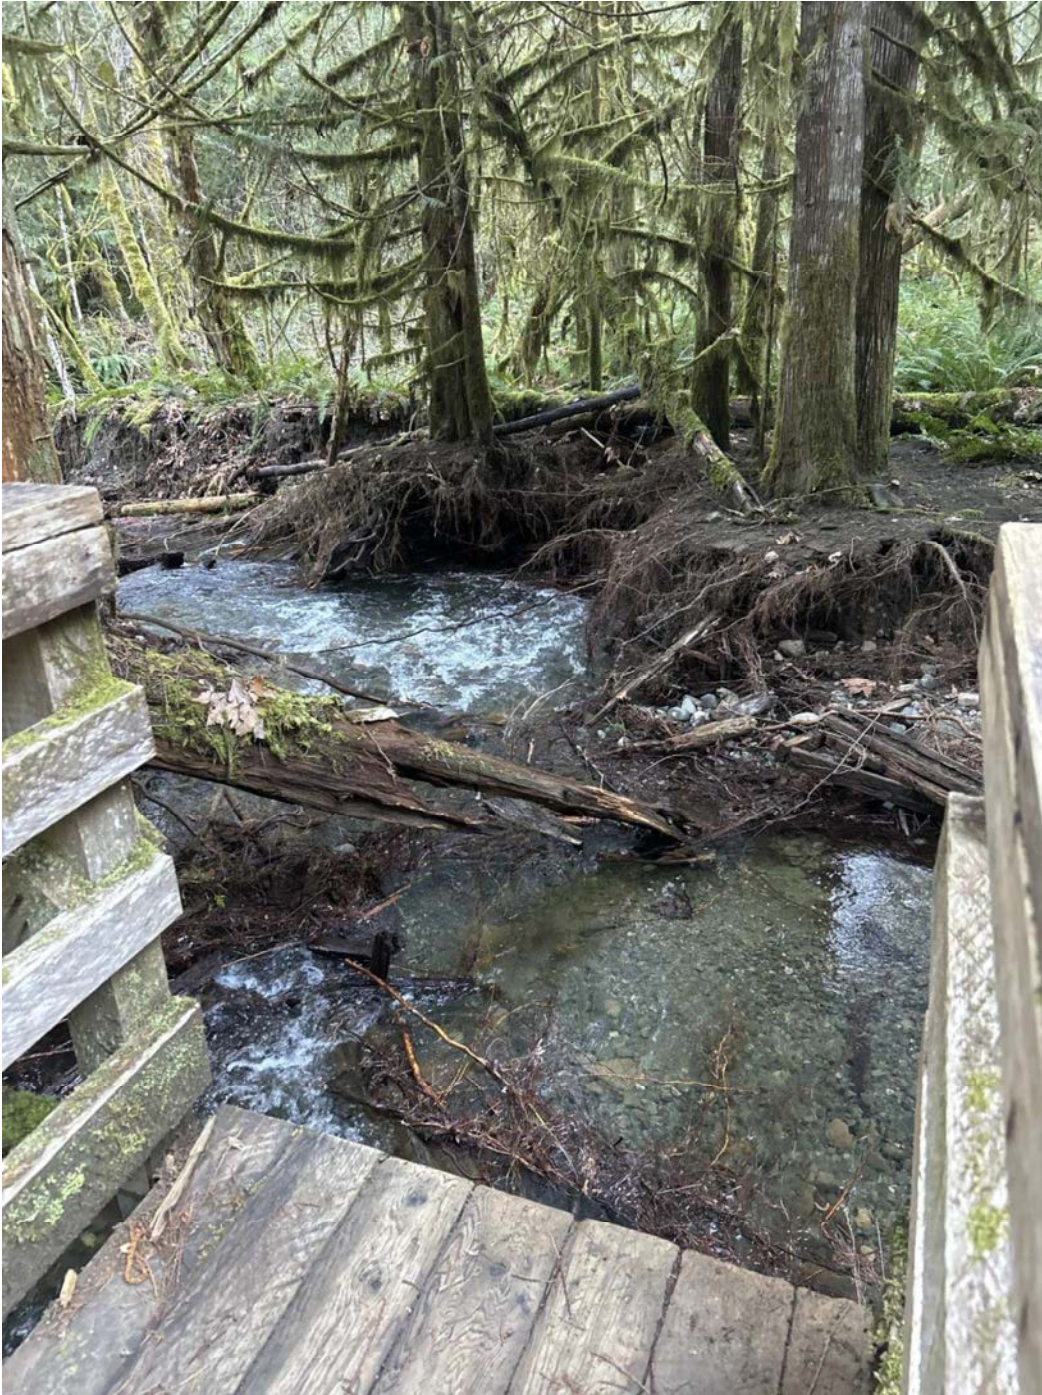
**Figure 3.5** Photograph looking downstream at the avulsion channel on April 7, 2026, showing water flowing into the channel from below the bridge.

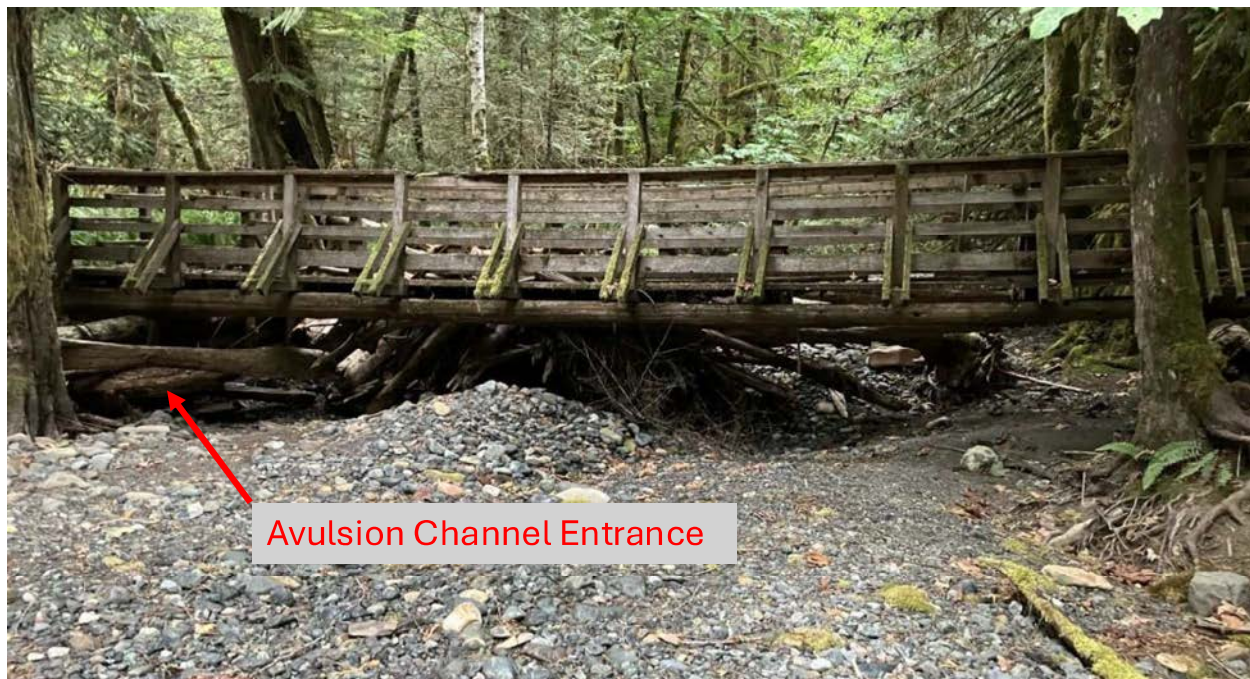
**Figure 3.6** Looking upstream at the downstream side of trail bridge. Log jam on upstream side of bridge. Avulsion channel entrance as annotated. Photo taken July 16, 2026.

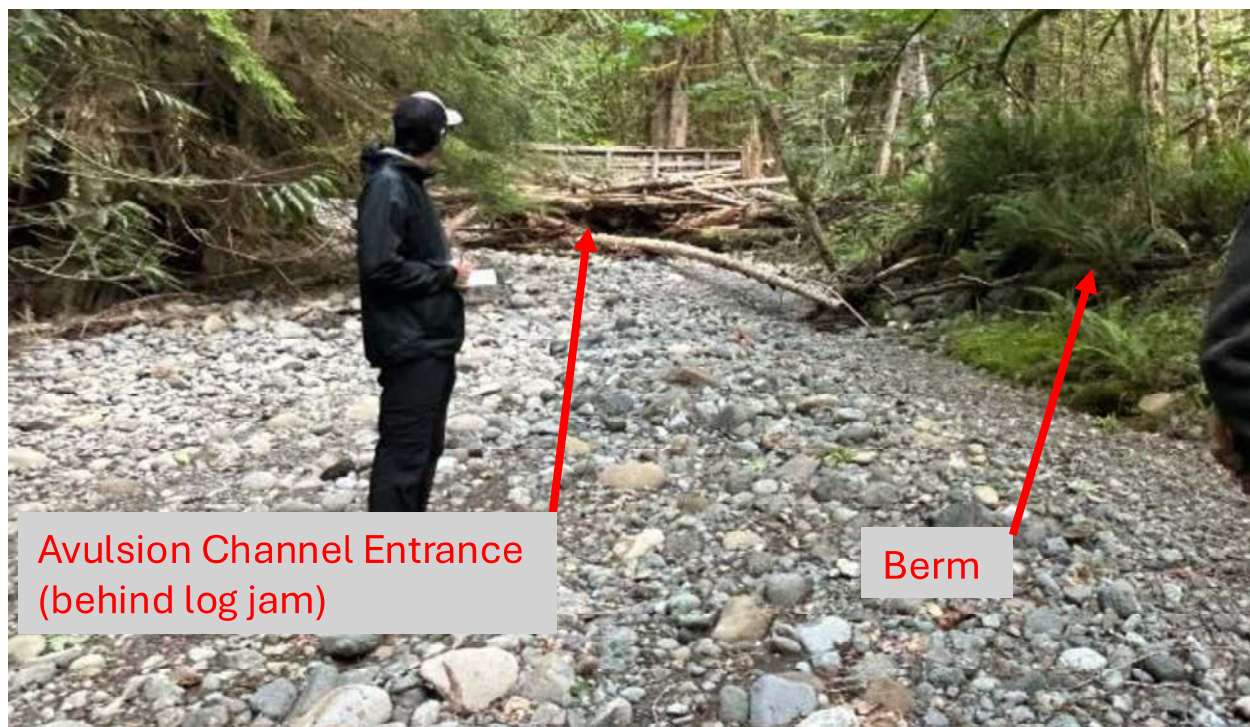
**Figure 3.7** Looking downstream at trail bridge and log jam accumulated on it. Photo taken June 10, 2026.
