COUNCIL REPORT

SUBJECT: Coal Valley Estates Phase 11 – Application for an Environmental Protection (DPA #1) and Wildfire Urban Interface Development Permit (DPA #4).

FILE:	2019-08-DP		
AGENT:	Chris Durupt, PEng, McElhanney	OWNER:	Coal Valley Estates
FOLIO No.:	516 000394.545	PID:	003-634-264
LEGAL DESCRIPTION:	DISTRICT LOT 24, NELSON DISTRICT, EXCEPT PARTS IN PLANS 21 RW, 522E, 3130, 3268, 4222, 4661, 4824, 4869, 6793, 6794, 11068, 12569, 13409, 13580, 13640, 14028, 15750, 23224, 19381, 19382, 19383, 20746, 21025, 22199, 23092, 23237, 23600, 23685, 24001, 24314, 24868, 25906, 26084, 26131, 26455, 26629, 26885, 27337, 27857, 29860, 30068, 30809, 32692, 35790, 36785, 35098, 50021, VIP64546 VIP65968, VIP65482, VIP67269, VIP71673 AND EXCEPT PARCEL A (DD 27356N) AND PARCEL B (DD M7897) AND EXCEPT PARTS IN PLANS VIP72020, VIP72021, VIP72022, VIP73804, VIP74156, VIP75434, EPP15708, EPP17313, EPP18594, EPP20118 EPP53358 , EPP71701, EPP79979 AND EPP90590		
CIVIC ADDRESS:	Penrith Avenue		
OCP DESIGNATION	Mixed Land Use	ZONE:	Mixed Use One (MU-1)

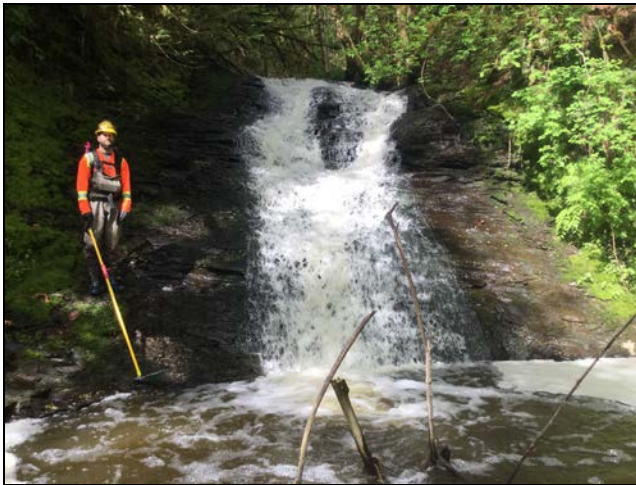
Photo 1: 7m high falls located +8km downstream of the property are a definable barrier to upstream fish movement from the Trent River.

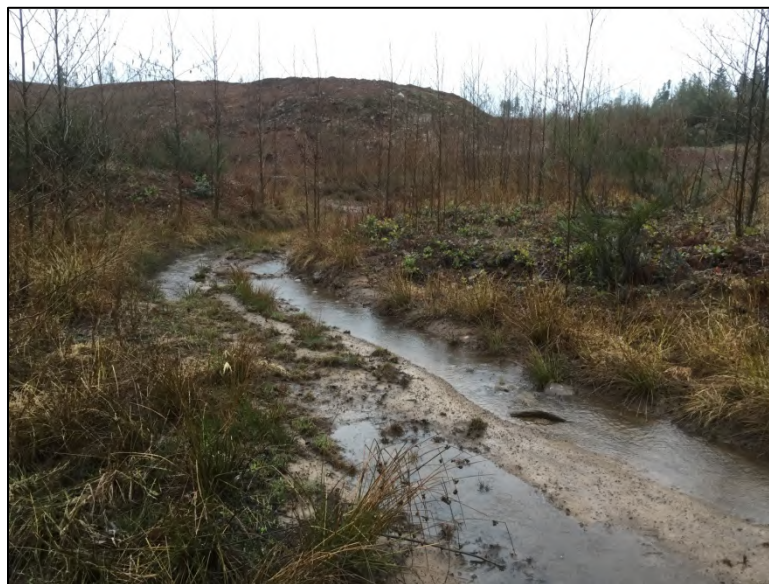
Figure 4: View of typical habitat available within northern section. Picture showing some surface runoff during heavy precipitation.

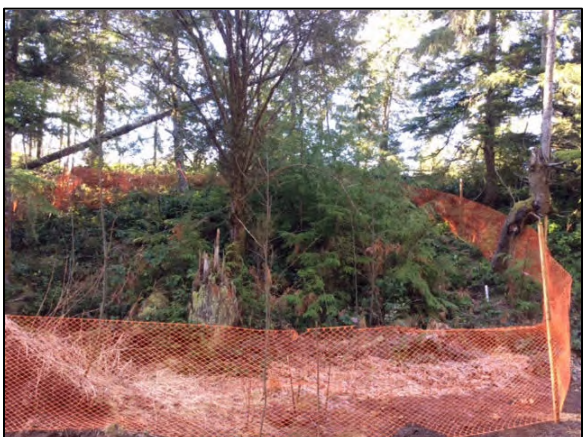
Figure 10: A Pacific yew identified in 2014 has been delineated to ensure it is protected.

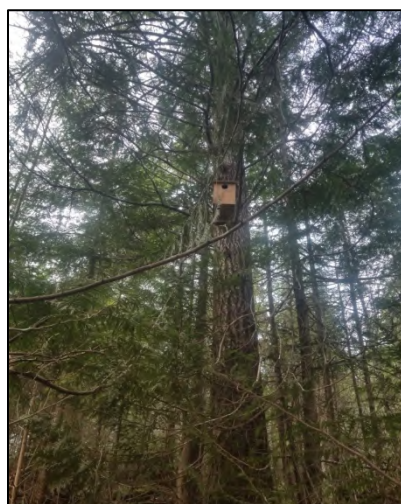
Figure 11: Three Western screech-owl boxes have been installed within the riparian greenway.

The southern section of the property includes an area of approximately 17.6ha (Figure 5). This area includes the riparian greenway surrounding a seasonal stream/wetland with intact riparian vegetation (Figure 6). The areas surrounding the riparian area were previously harvested and are in an immature re-generating forested state (Figures 7-9). A water transmission main was installed along the access road at the east side of this section as part of a previous phase of the development. A Pacific yew tree that was identified in the previous bio-inventory work was marked and protected during the works (Figure 10) and will be retained during future development. Three Western screech-owl nest boxes were constructed and installed within the riparian greenway to provide suitable nesting structures for the blue listed owl species (Figure 11).

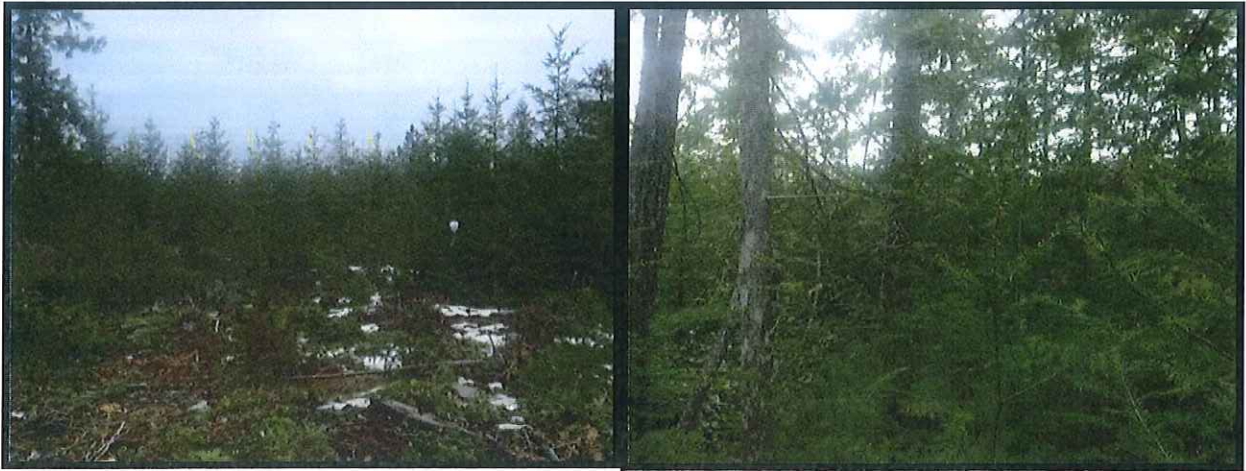
Figures 1-2. From left to right: regenerating conifers and open area with salal, bracken fern and Scotch broom; dense conifer stand with small diameter overstory.

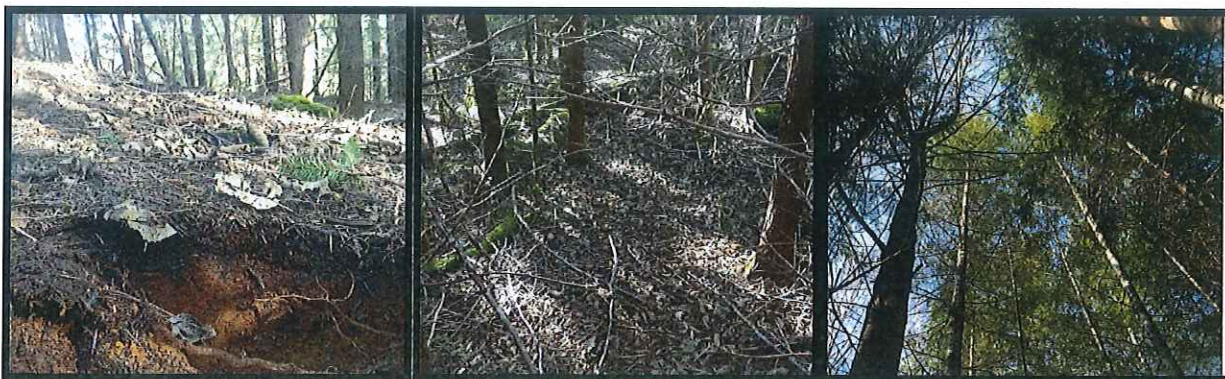
Figures 3-5. From left to right: thin duff layer; surface fuels; 80%+ coniferous crown closure with deciduous component.

The overall Wildfire Behaviour Threat Score was 99 out of a possible total of 240 resulting in a High Threat Class. Figures 3 to 5 below are representative photographs of the vegetation in the Central Park - West.

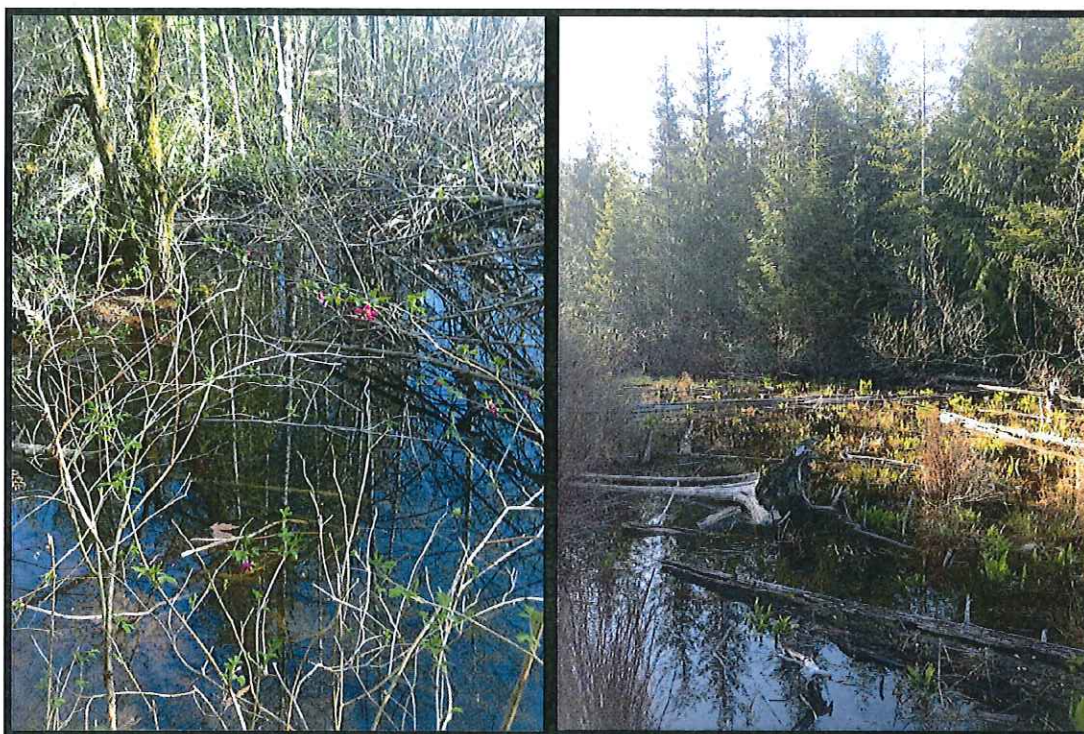
Figures 6-7. From left to right: standing water and deciduous tree and shrub species; wetland and riparian vegetation as well the break in forest cover.

The wetland has standing water and has lush, riparian vegetation around its perimeter for approximately 5 m. The wetland and surrounding vegetation could act as a fuel break, and likely provides a summer water source for wildfire suppression. Figures 6 to 7 are representative photographs of the vegetation in wetland portion of the Central Park - West area.

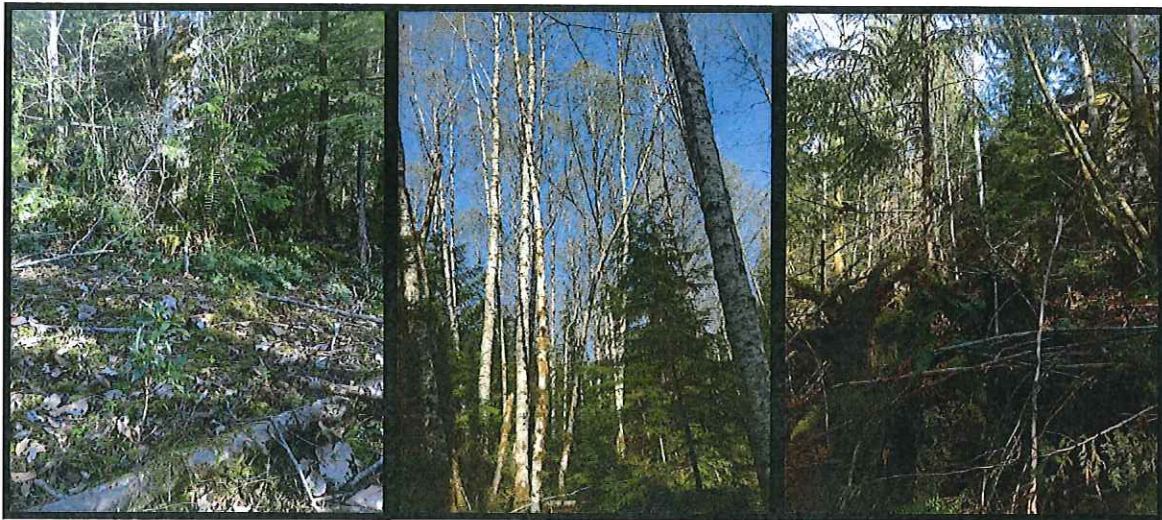
Figures 6-8. From left to right: ground cover; overstory red alder with immature hemlock in the understory; rock cliff with some large woody debris.

This area has a Wildfire Behavior Threat score of 67 out of a possible 240 resulting in a Moderate Wildfire Behaviour Threat Class. Figures 6 to 8 below are representative photographs of the vegetation in the East Area.

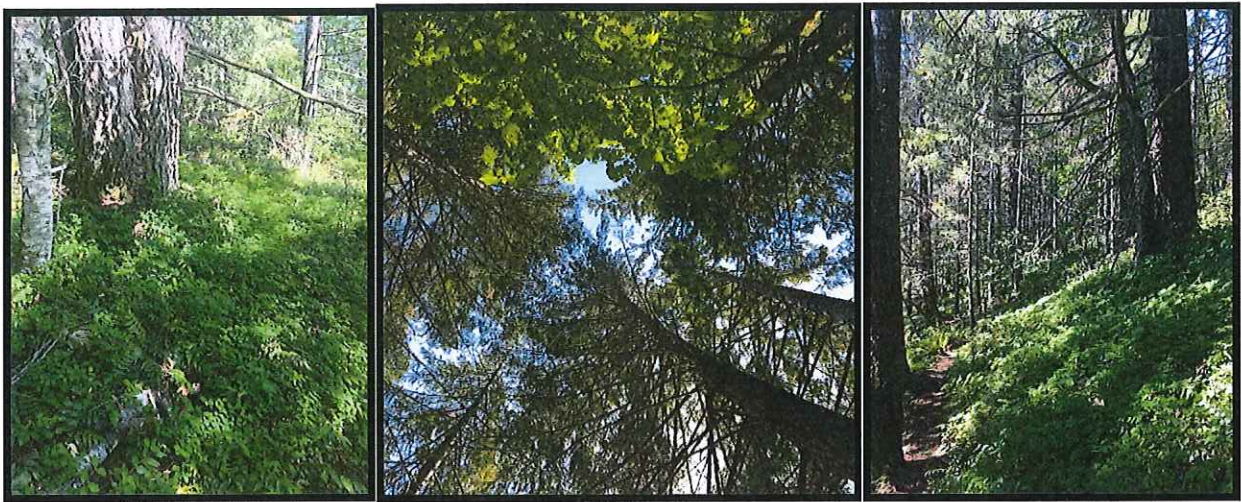
Figures 9-11. The south park from left to right: ground cover; Douglas -fir overstory with big-leaf maples; the understory.

The area has a Wildfire Behaviour Threat score of 74 out of 240 resulting in a Moderate Threat Class. Figures 9-11 5 below are representative photographs of the vegetation in the South Park.

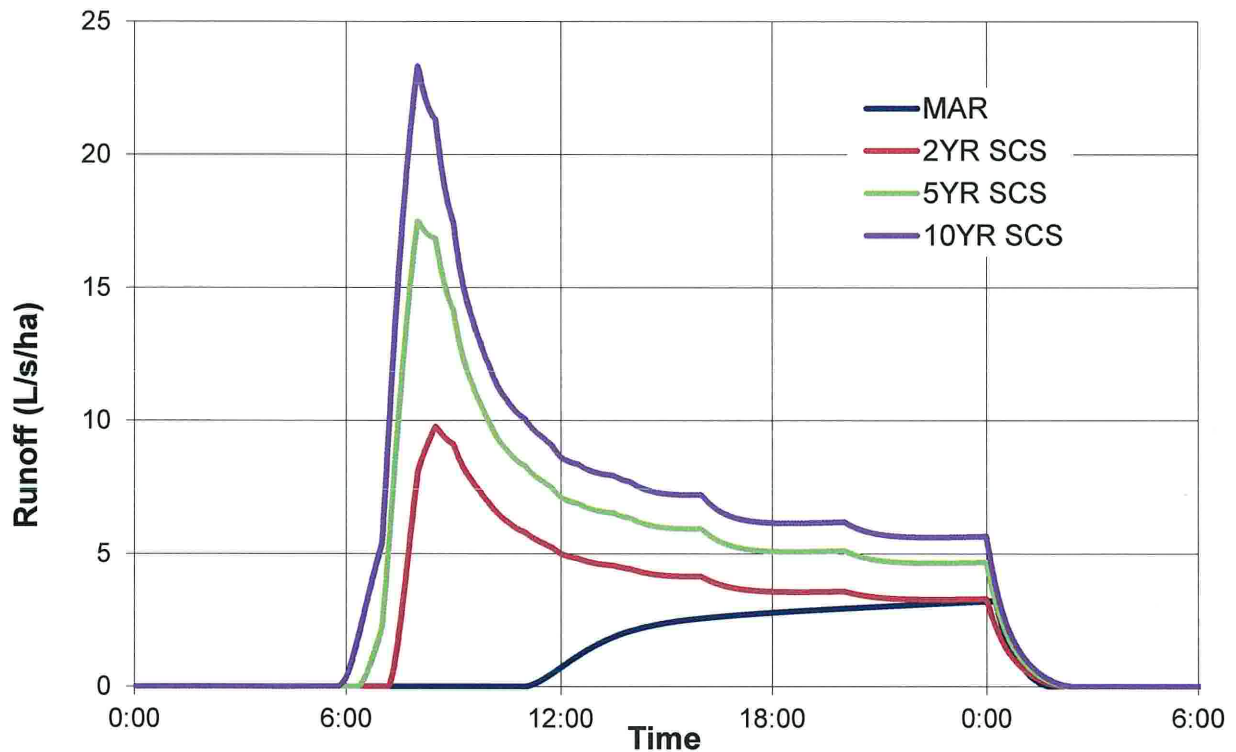
Figure 1: Hydrographs for the MAR, 2, 5, and 10 Year Rainfall Event under Present Day Site Conditions

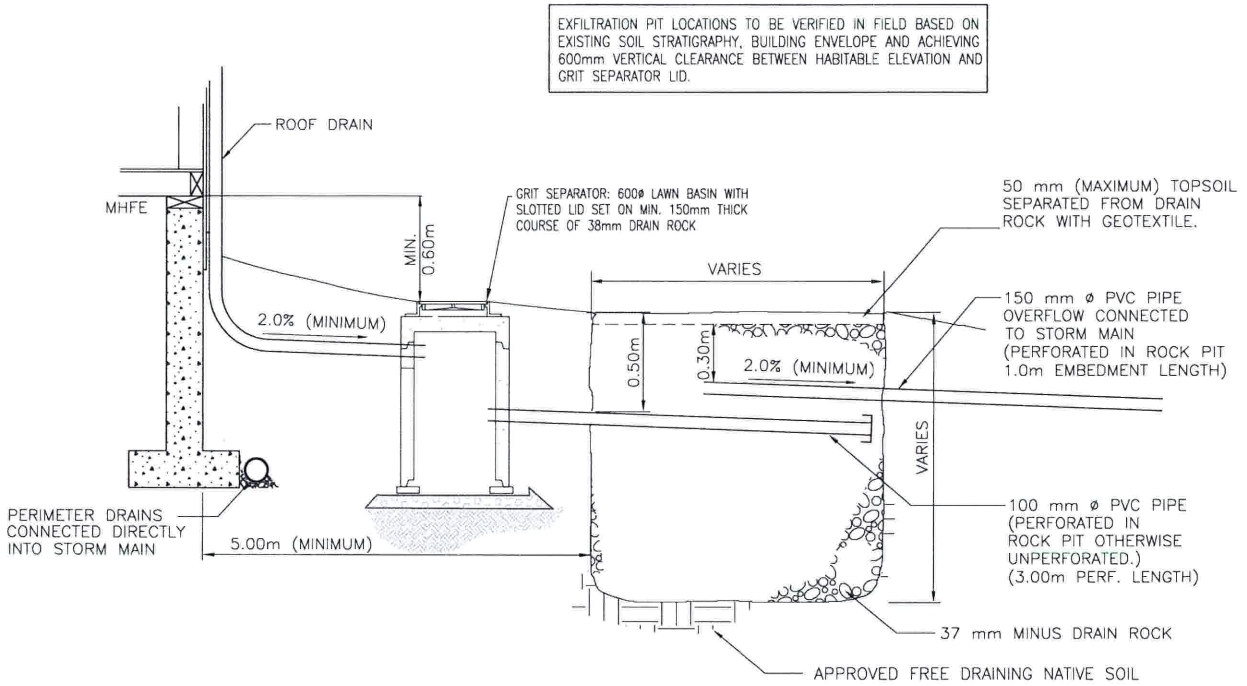
Figure 2: Typical Lot Level Infiltration Gallery

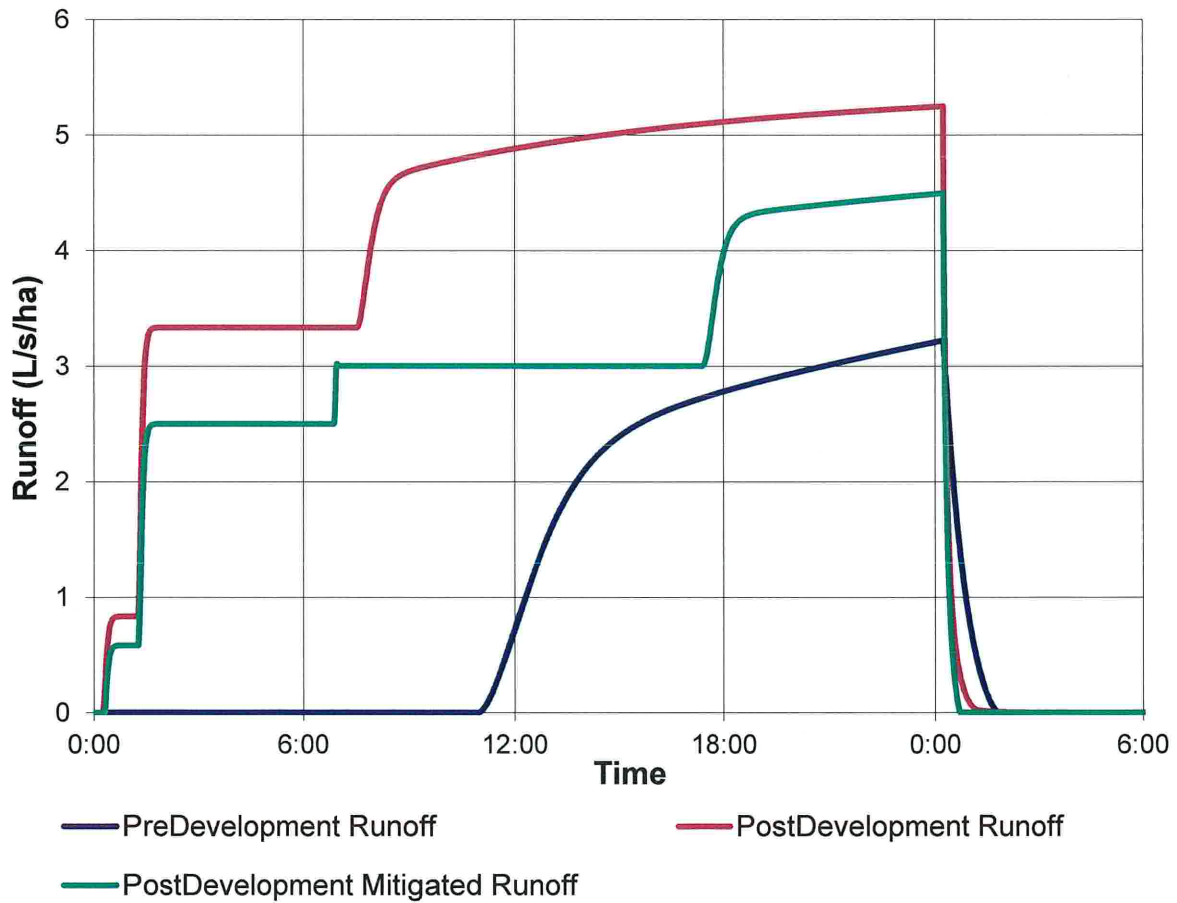
Figure 4 – LID Performance: MAR Event

Table 5 below, compares pre- and post-development simulated runoff quantities for the site on a per hectare basis. The analyses show that with the use of LIDs as proposed herein, post-development runoff can be infiltrated, evapotranspired, detained and released at a reduced rate. Peak runoff in excess of pre-developed rates as well as increased post development runoff volume, will be attenuated by the downstream wetlands.

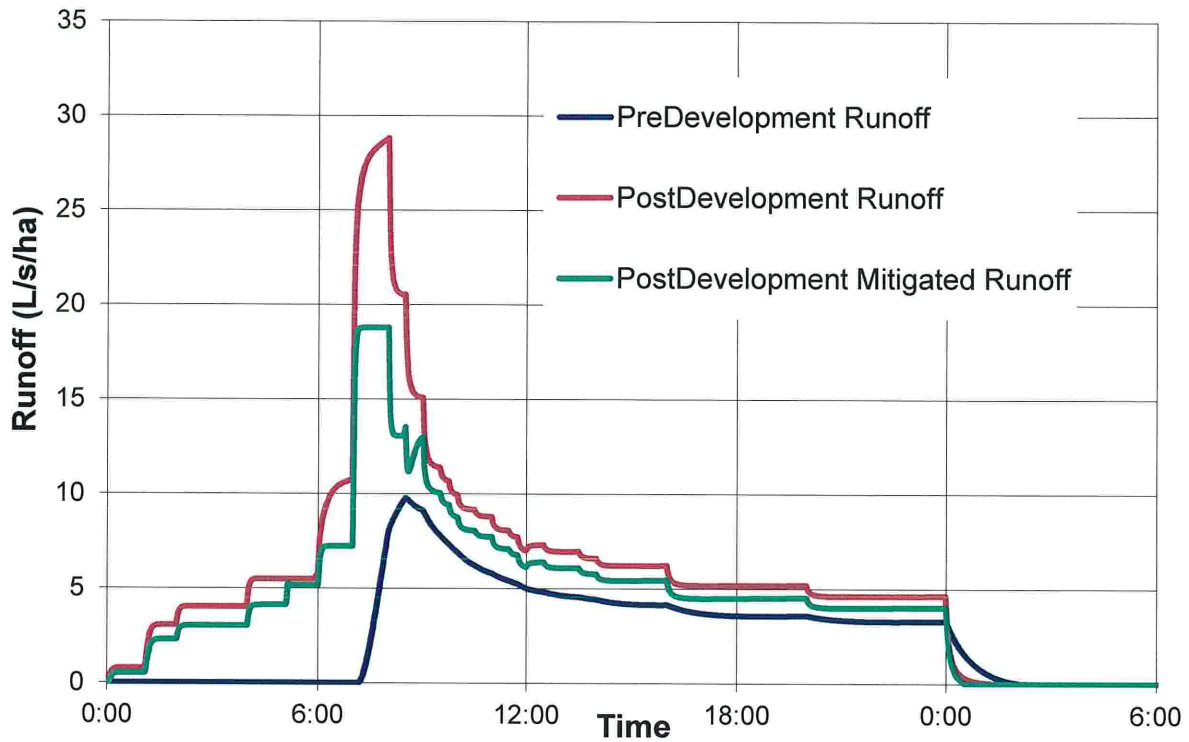
Figure 5 – LID Performance: 2YR Event

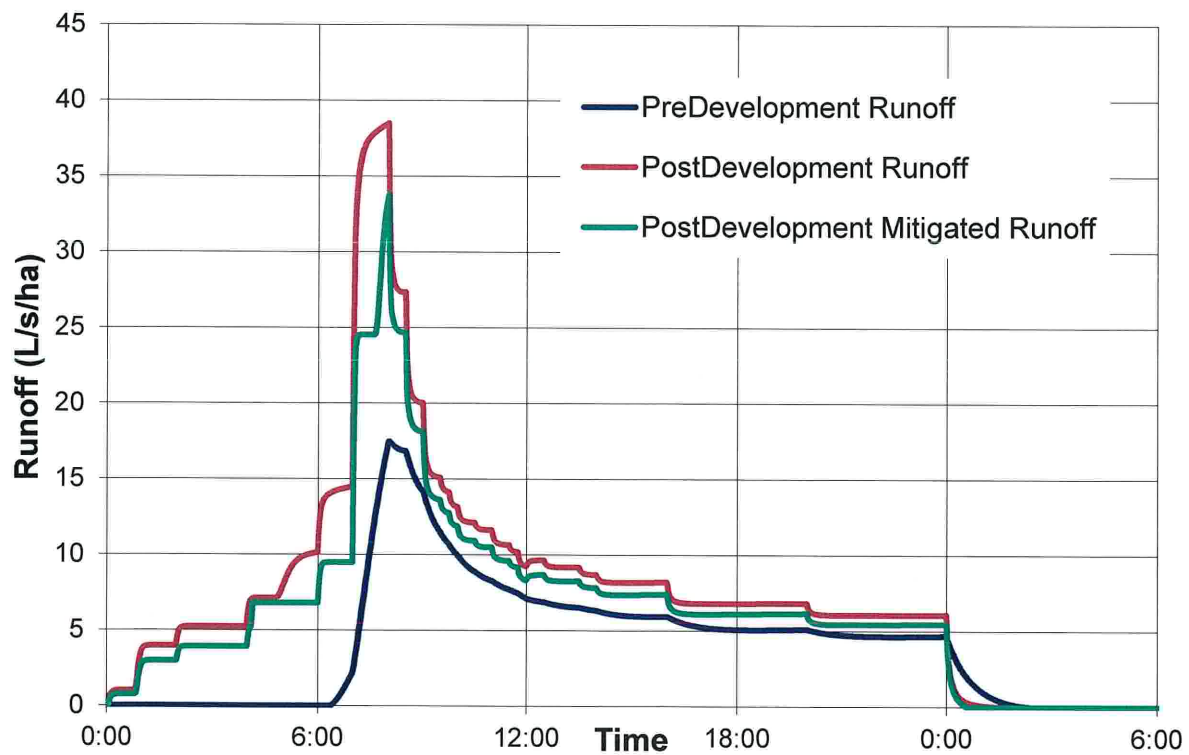
Figure 6 – LID Performance: 5YR Event

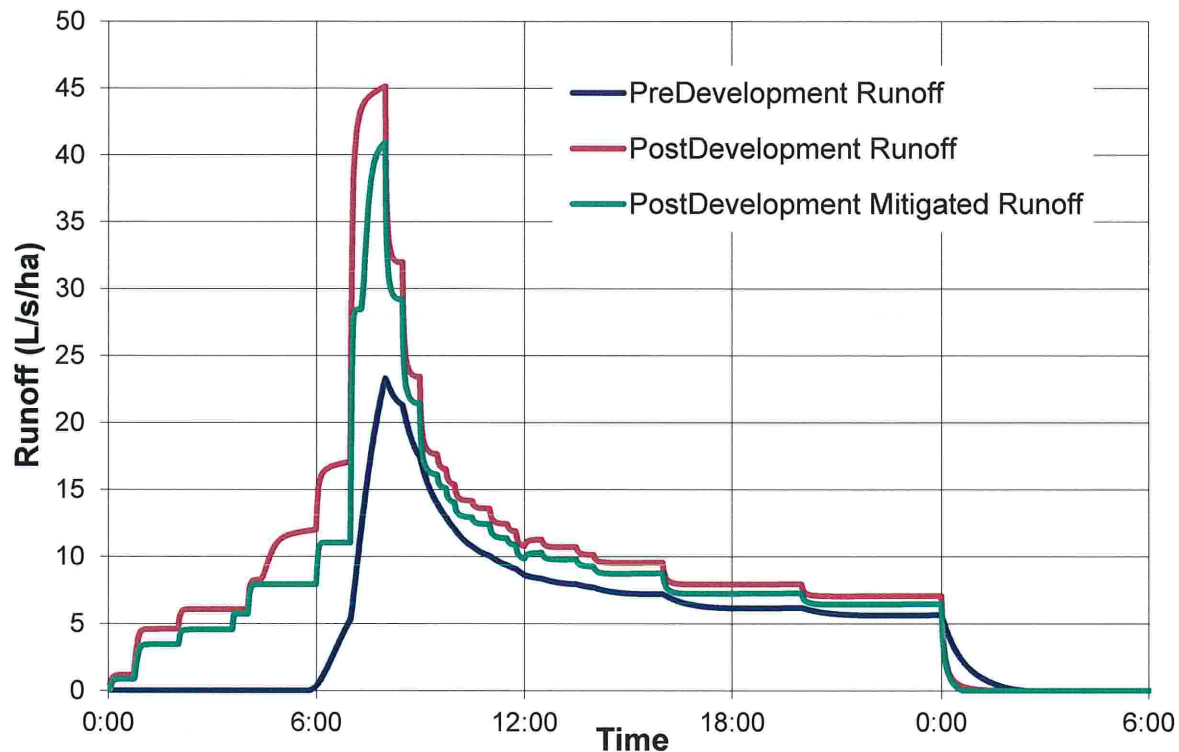
Figure 7 – LID Performance: 10YR Event
