The Corporation of the Village of Cumberland  
Committee of the Whole Meeting Agenda

4.1 Perseverance Creek Flood Risk Assessment  
Prepared by Kevin McPhedran, Director of Community Services

# Perseverance Creek Flood Risk Assessment

## Options Analysis and Class 1 Risk Assessment

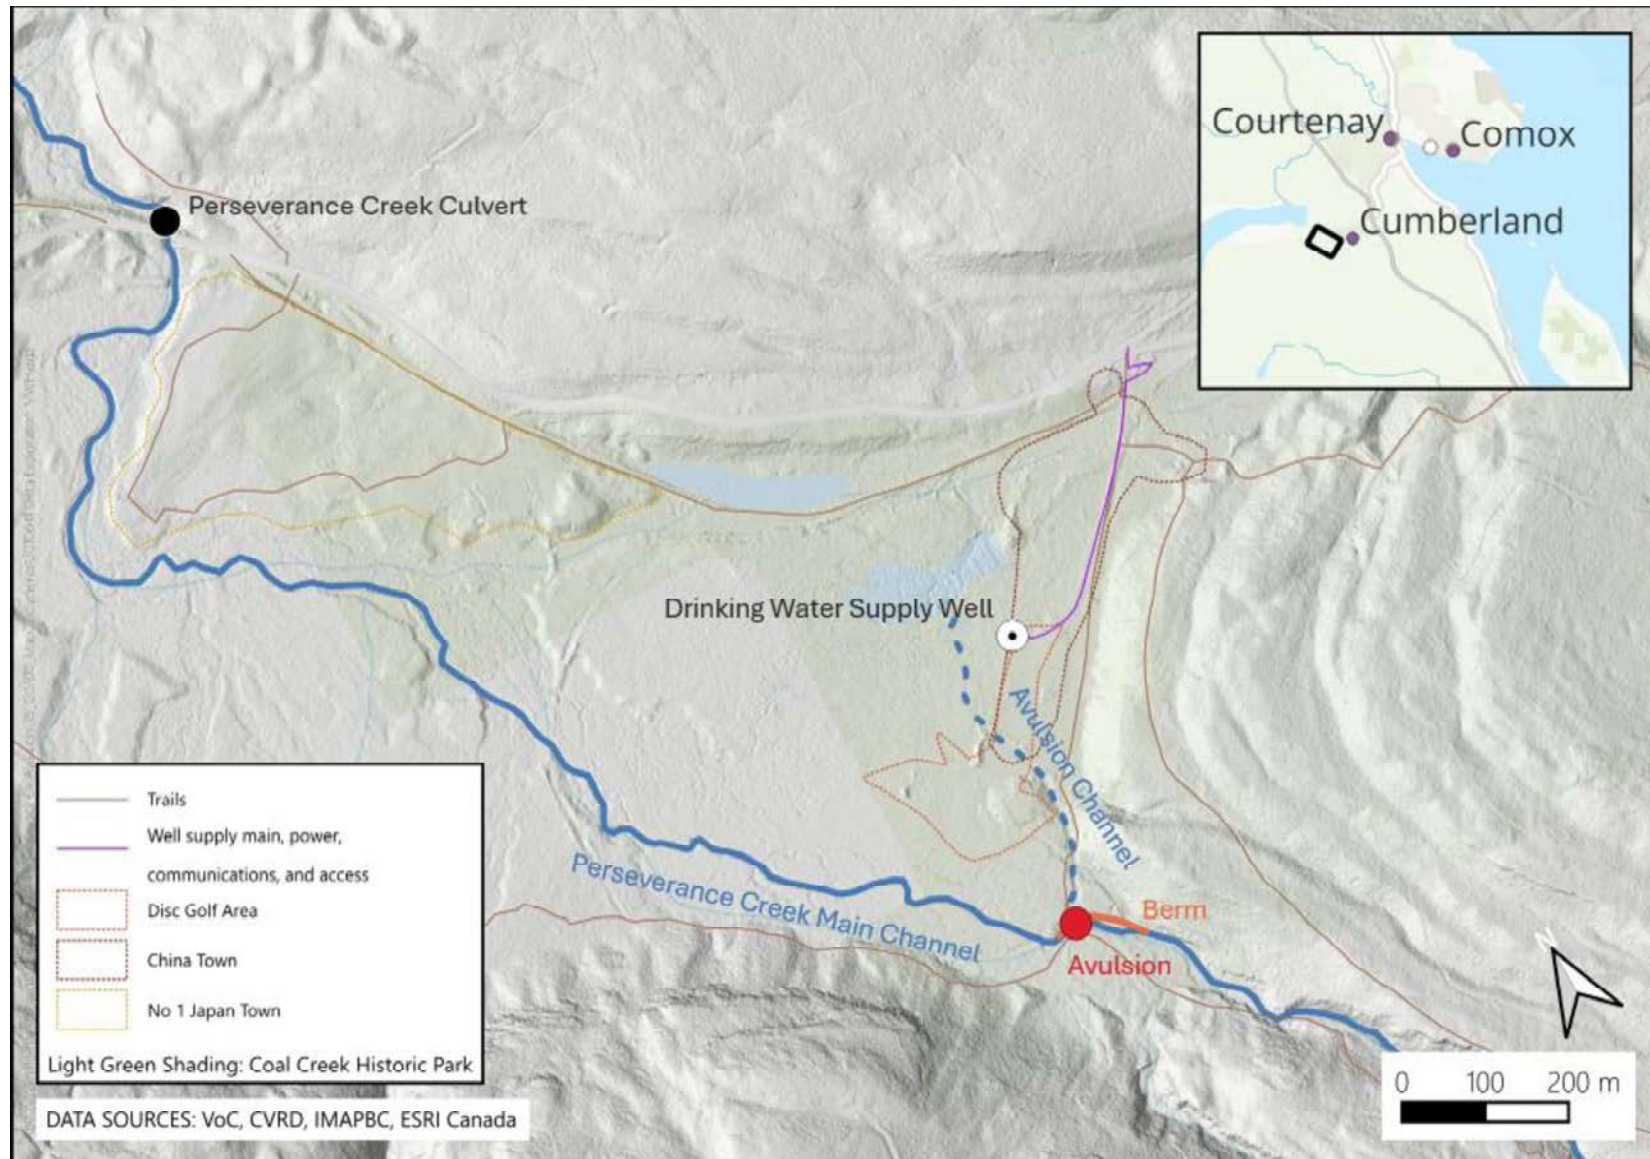
**Figure 1.4** Map showing avulsion location and nearby infrastructure.

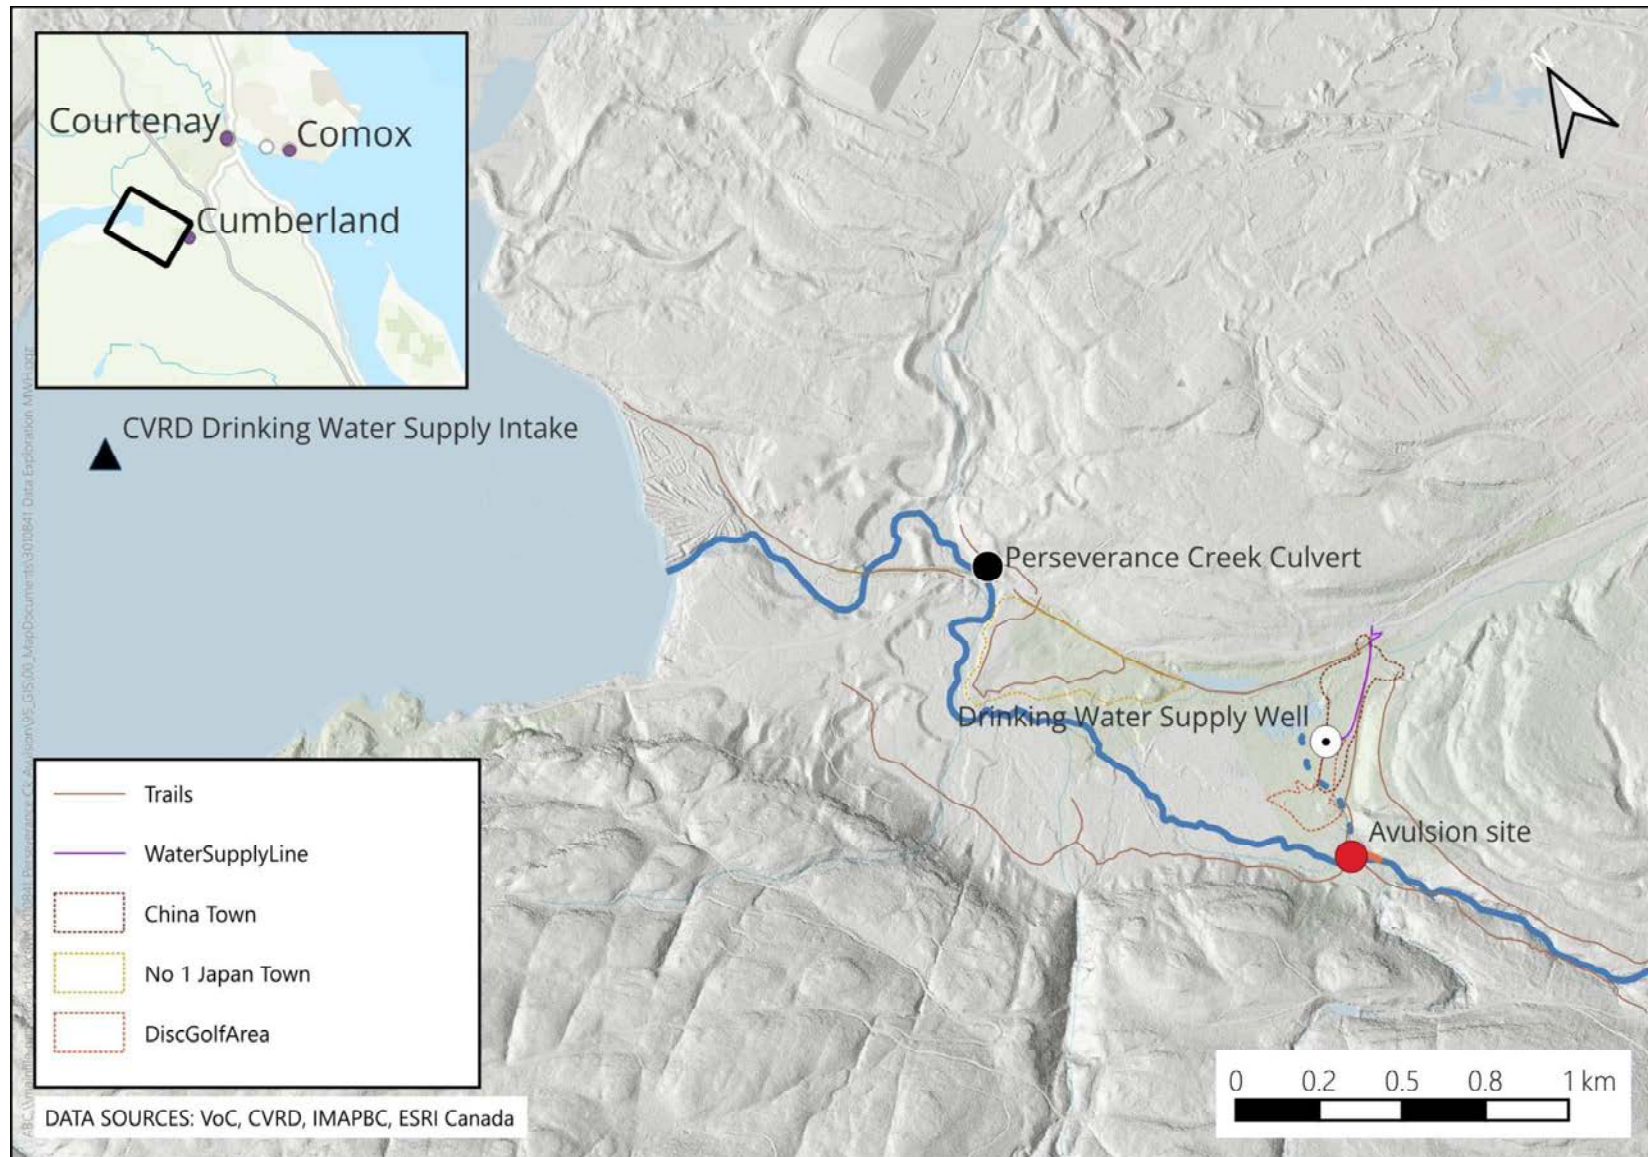
**Figure 3.1 Overview map showing elements considered in risk assessment.**

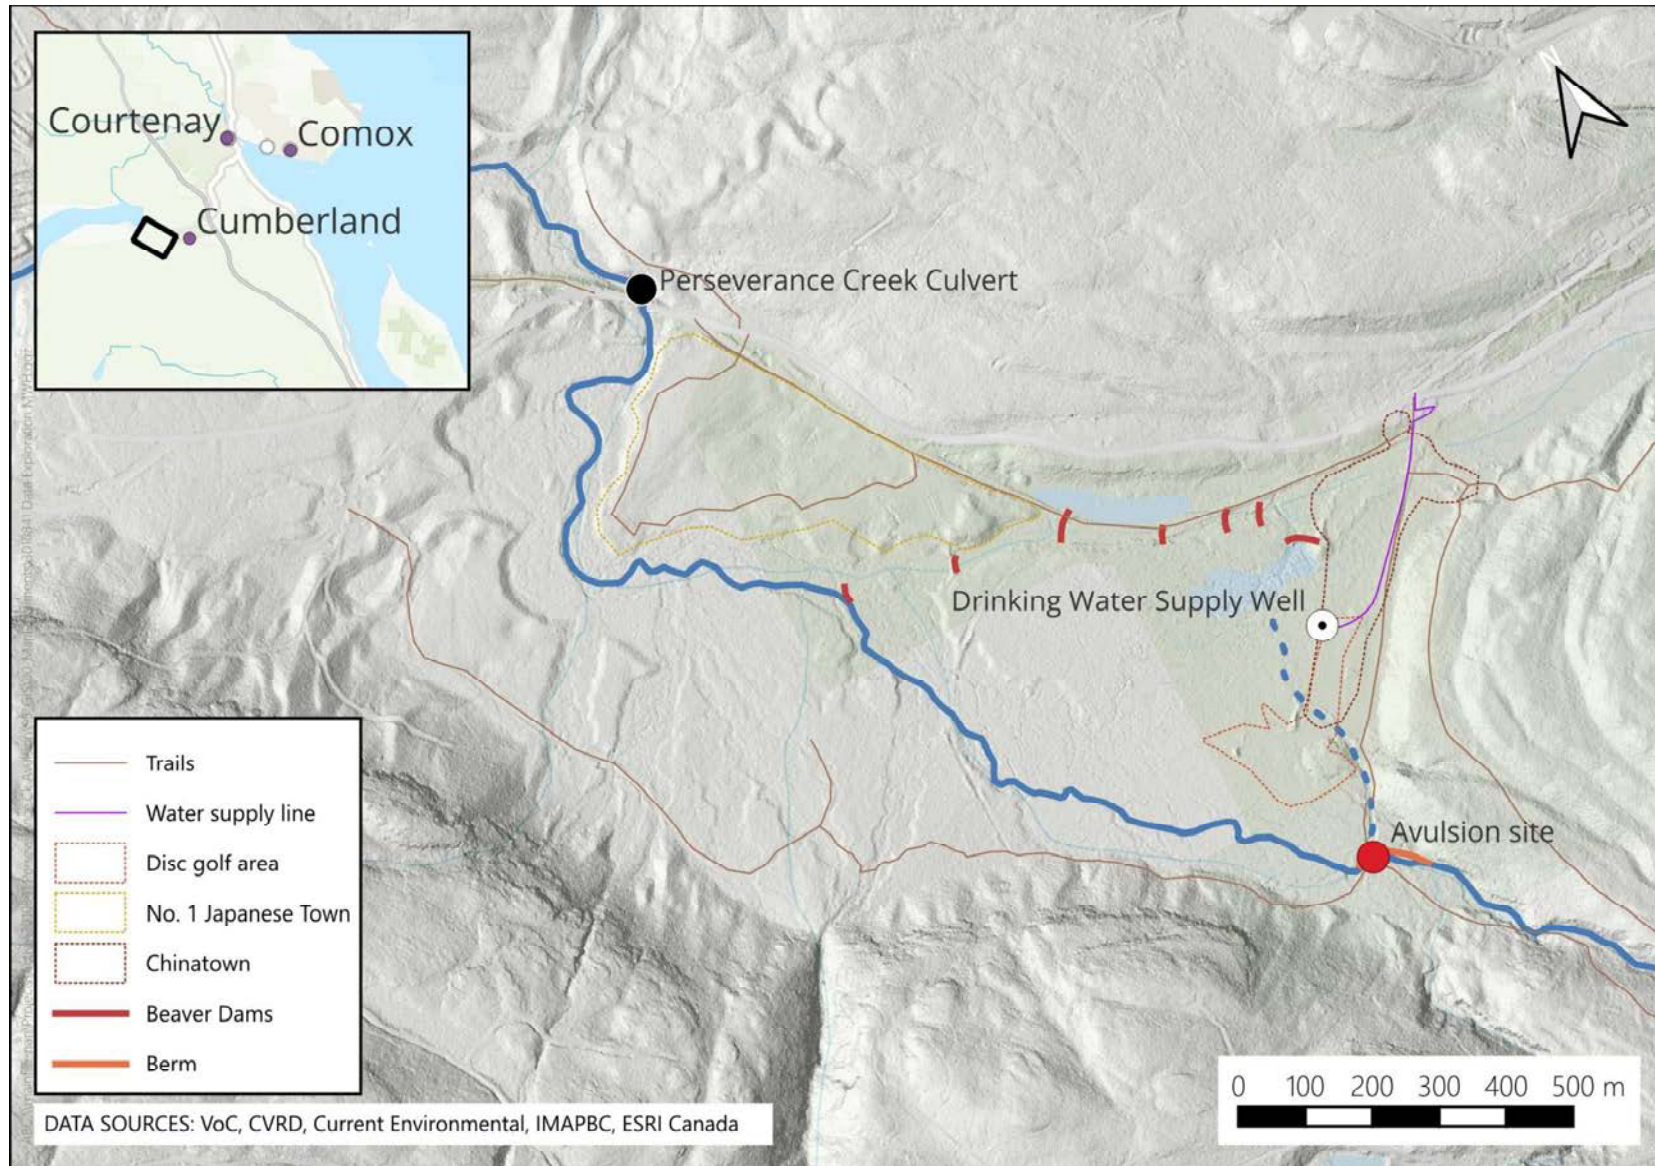
**Figure 3.2** Closer view of avulsion site, elements, and hydraulic control structures in study area.

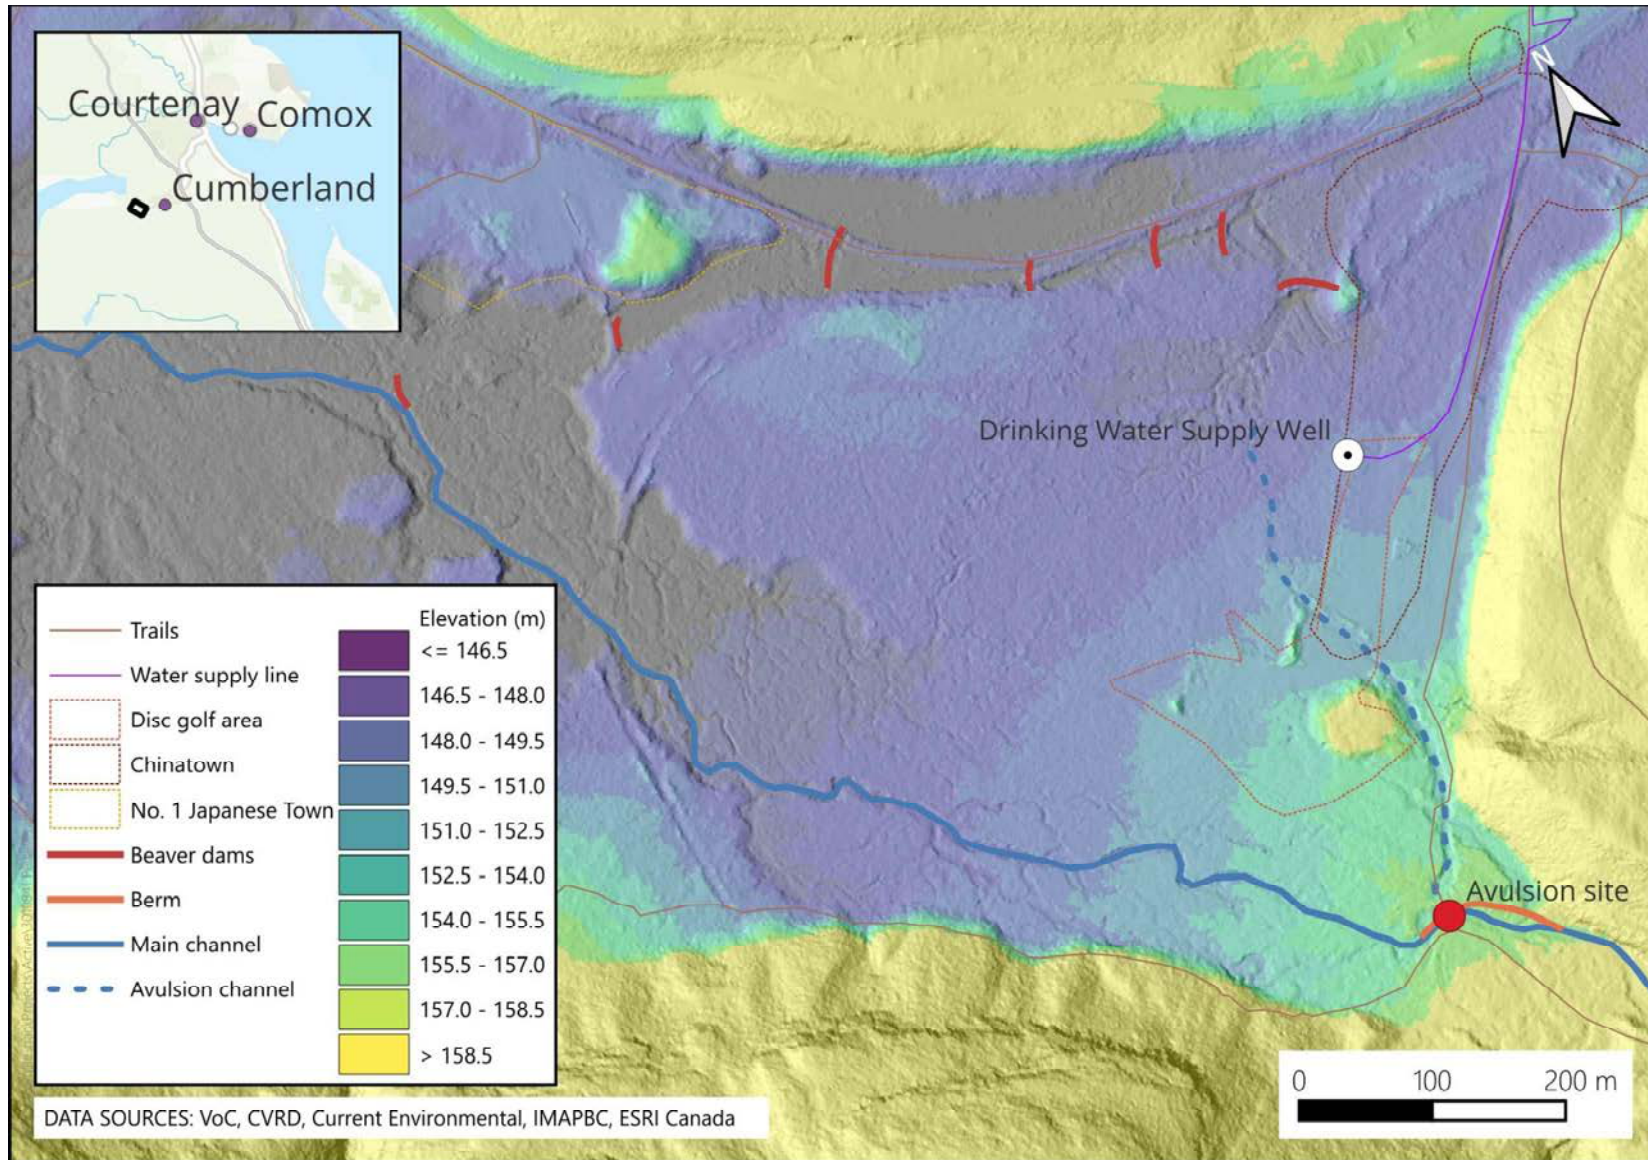
**Figure 3.3** Map showing avulsion site and elements within alluvial fan, illustrated by elevations based on CVRD Lidar.

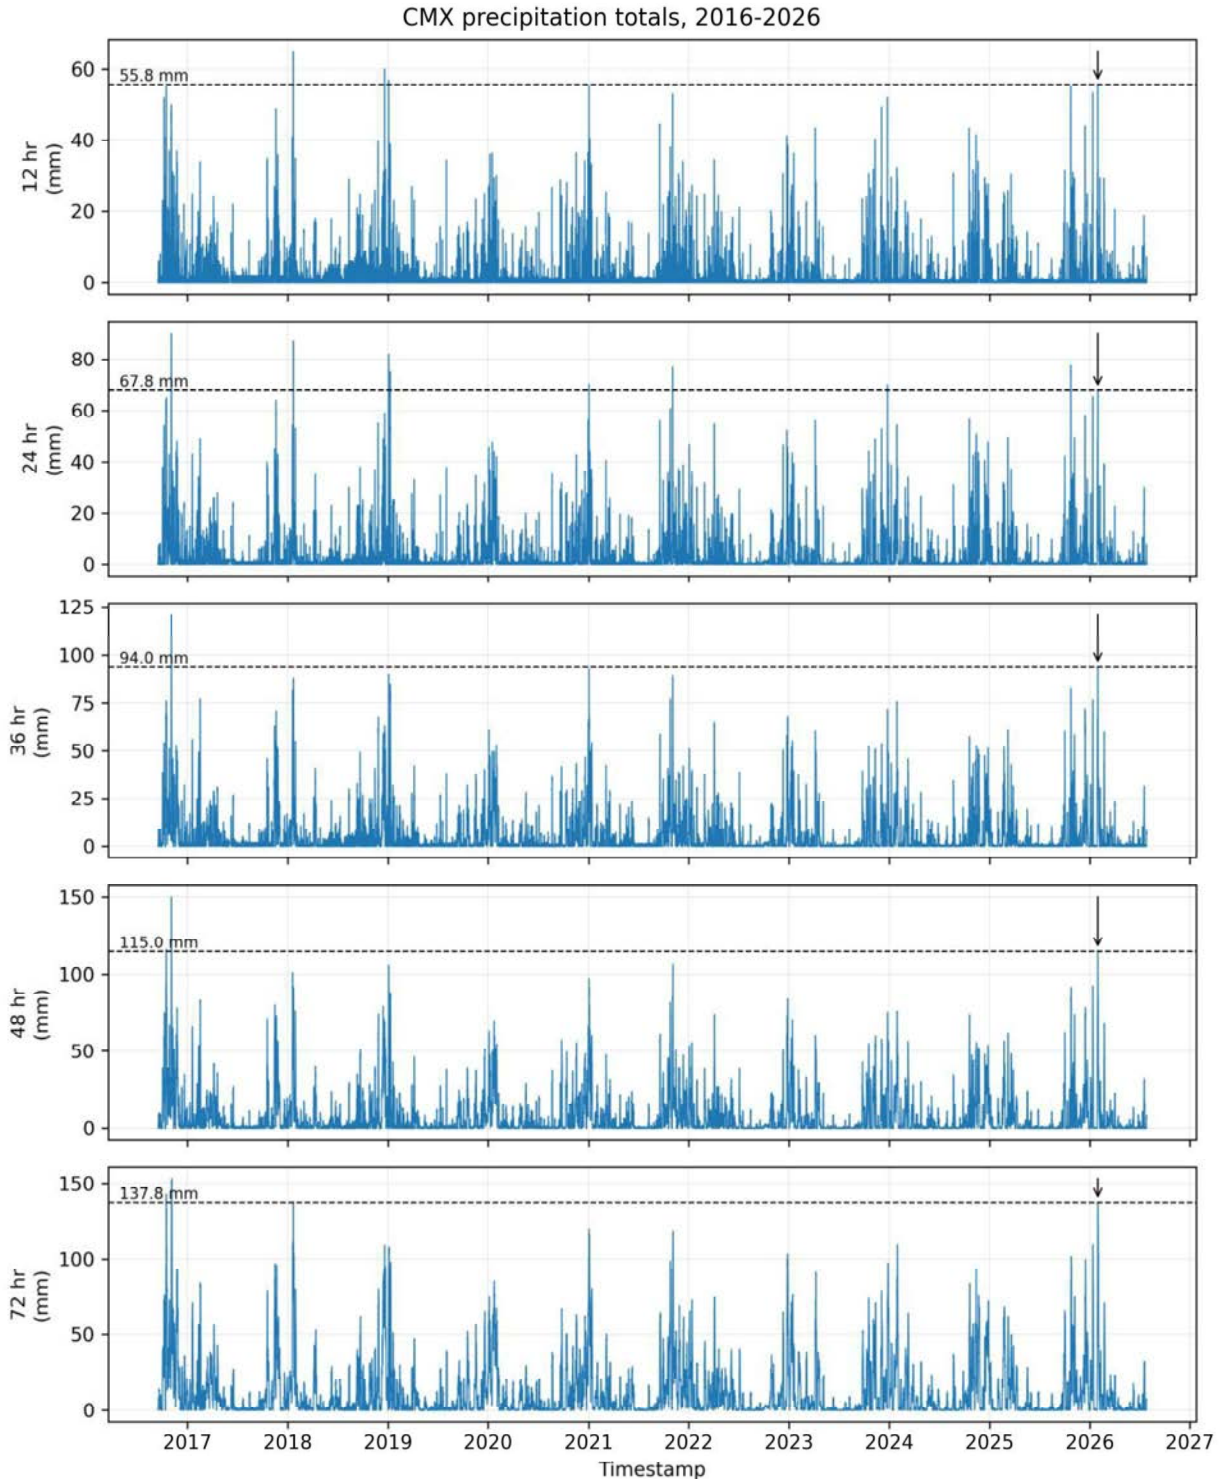
Comparison of the values in Table 3.1 with 12, 24, 36, 48, and 72 hr precipitation totals at CMX since the winter of 2016-2017 provides context for how the January 30 storm event compared to historic storms (Figure 3.8). The 12 and 24 hr totals observed during the January 30 event have been observed in at least half of the years since the winter of 2016-2017. The longer duration totals stood out more, but have still been observed several times: twice for the 36 and 48 hr totals, and three times for the 72 hr total<sup>2</sup>. This suggests that the January 30 storm was significant but not unprecedented; it is within the range of expected winter conditions.

**Figure 3.8** 12, 24, 36, and 48 hour precipitation totals at BC Hydro's Comox Dam Forebay station. Arrows indicate the January 30, 2026 avulsion, with the dashed lines indicating the precipitation totals from that event.

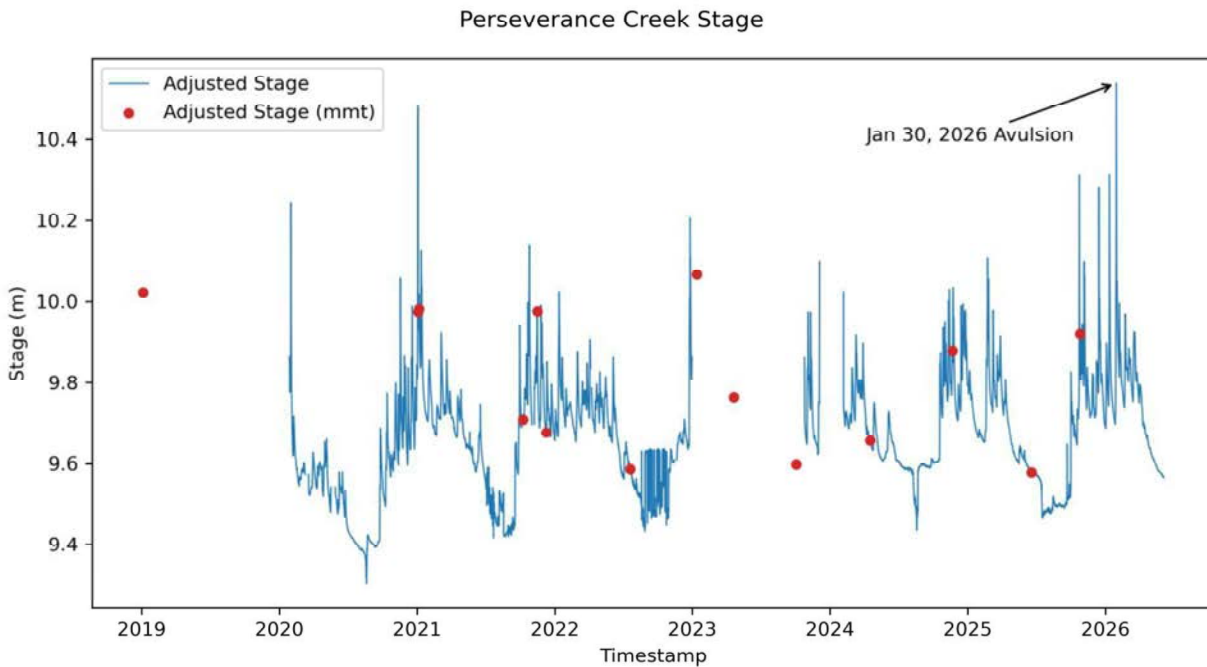
The Comox Valley Regional District (CVRD) has operated a hydrometric station on Perseverance Creek at the Davis Lake Main Forest Service Road crossing since 2020. Preliminary stage data (water level relative to an arbitrary reference datum) are shown in Figure 3.9, with the January 30 event annotated. While the data are preliminary and uncorrected, there are two takeaways:

2. Stage values during summer low flow conditions were approximately 0.1 m lower in 2021 and 2022 than they have been since. Hydrometric reports made available for this assessment state the creek dries up each summer. Stage values during summer low flow conditions are therefore measuring the channel bed elevation. The 0.1 m rise over the data record suggests 0.1 m of aggradation under the water level sensor, illustrating that sediment transport occurring in Perseverance Creek.

While the hydrometric data are preliminary, they support the same general conclusion as the precipitation data: the January 30 event was large, but within the range of observed recent historical conditions.

**Figure 3.9 Stage data at the Perseverance Creek hydrometric station, from 2020-2026**
